Manhole Inspection Summary

Manhole # S39EE_004MH

Insp Date: **1/12/08 2:37 PM**

Location Address: **1129 WILLING CT**

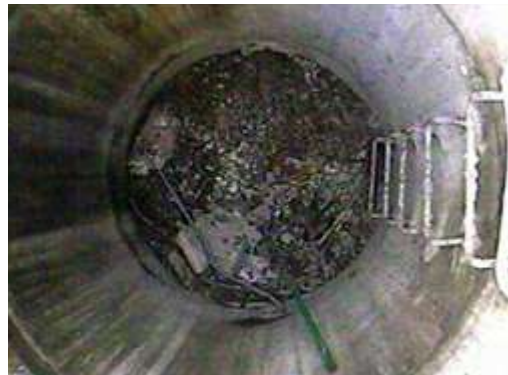
Defect 2

Steps Count: **7** Missing: **0** ☒ **Corroded**

Surcharge ☒ **Evidence Of Surcharge** Depth: **2** (ft.) ☐ Active Surcharge Present

evidence surcharge;corroded step

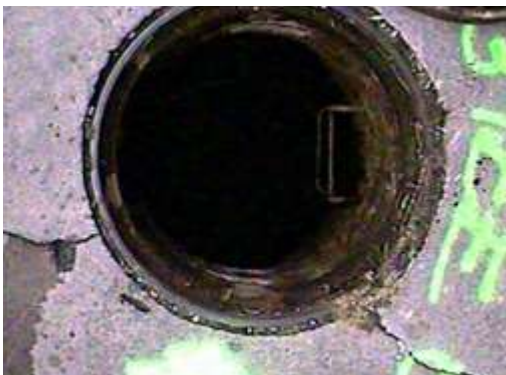
Defect 1

frame offset; loose bricks frame
adjustment

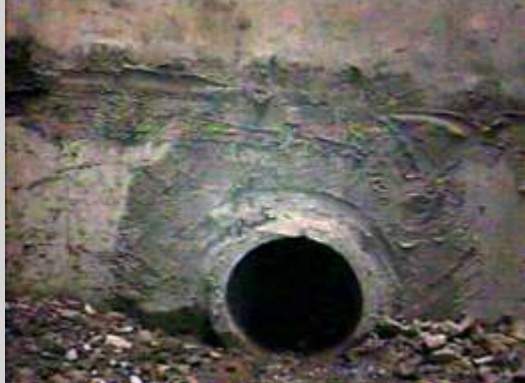
12 O'Clock Outflow

8 in. Circular Gravity Sewer
Pipe Out @ 12 O'Clock

Pipe Material: **Clay** ☐ Pipe Lined

Infiltration: **None** Pipe Seal Cond: **Sound**
